NATIONAL TRANSPORTATION SAFETY BOARD

MATERIALS LABORATORY FACTUAL REPORT

Report No. 08-003

Place : Carmichael, Mississippi
Date : November 1, 2007
Vehicle : Pipeline
NTSB No. : DCA08MP001
Investigator : Rick Downs-RPH

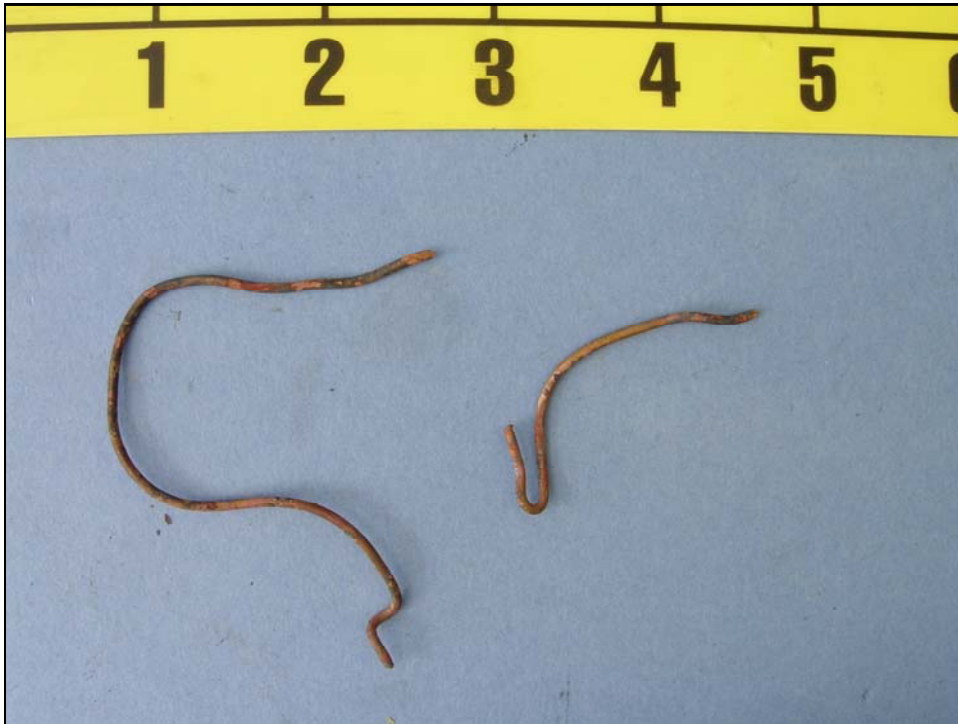
Image No.:0712A00562, Project No.: 2007120009

Two wires were submitted for examination. The wires are shown in Figure 1. The wires consisted of a single solid copper conductor. The ends had reportedly been twisted together to make the electrical connection for a hot water heater. Both wires were bare and no evidence of insulation was found on either wire. Upon microscopic examination, no damage, such as pitting, beading or erosion that would indicate an electrical arc, was found to the conductor of either wire. An example of the typical appearance of the surface of the wires is shown in Figure 2.

Figure 1. Overall of submitted wiring

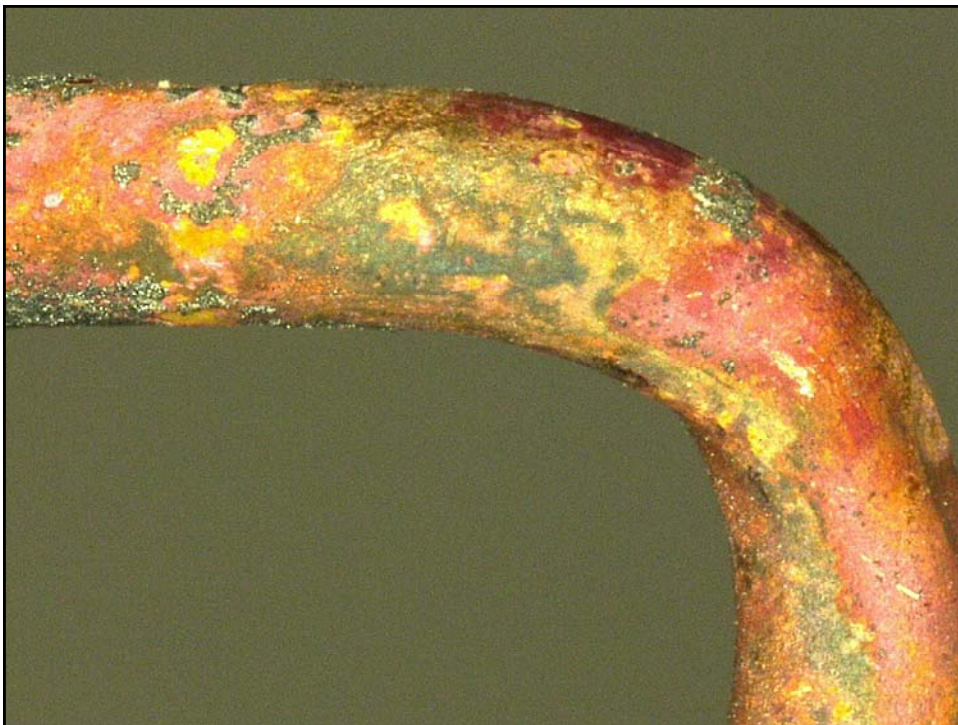
Image No.:0712A00566, Project No.: 2007120009

Figure 2. Close-up of wire surface
